## ASBESTOS REFURBISHMENT SURVEY REPORT

<b>Client</b>	London Borough of Camden
<b>Site</b>	Tenants Hall, Blemundsbury, Dombey Street, London, WC1N 3PF
<b>Date report issued</b>	26th August 2022
<b>Recommended Date for Reinspection</b>	15th August 2023
<b>Survey reference</b>	J765807
<b>Lead surveyor</b>	Kalum Hockley
<b>Assistant surveyor</b>	N/A
<b>UPRN</b>	68839

Tenants Hall, Blemundsbury, Dombey Street, London, WC1N 3PF

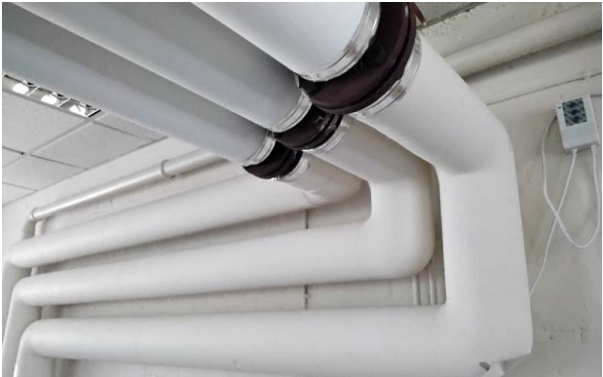
<b>Item / Inspection Ref:</b>	#4	Material Assessment	Product type:	2	
<b>Sample Ref:</b>	SY004165		Condition / Damage:	1	
Survey date:	15/08/22 TO 16/08/22		Surface Treatment:	2	
Analysis date:	August 18 2022		Asbestos Type:	1	
Building:	Tenants Hall		<b>Material Score:</b>	<b>6</b>	
Floor level:	Ground Floor		Priority Assessment	Occupant Activity:	1
Room:	Hall			Location:	2
Position:	Pipes			Accessibility:	1
Item Description:	Gasket in pipe and vessel joints - Boiler, Vessels and Pipework			Extent/amount:	1 6no.
Level of Identification:	SAMPLED			Number of Occupants:	0
<b>Action:</b>	Remove	Frequency of Use:		3	
<b>RISK CODE:</b>	<b>C</b>	Time in Area:		1	
		Maintenance activity:		1	
		Frequency of Maintenance:		1	
		<b>Priority Score:</b>		<b>6</b>	
		<b>Total Score:</b>	<b>12</b>		
<b>Comments:</b>	Gasket

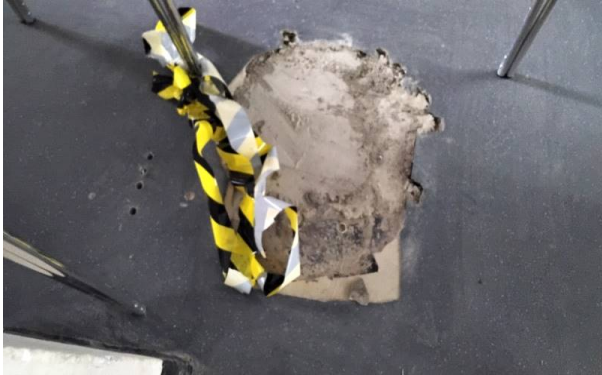
<b>Item / Inspection Ref:</b>	#5	Material Assessment	Product type:	1

<b>Sample Ref:</b>	SY004166		Condition / Damage:	1		
Survey date:	15/08/22 TO 16/08/22		Surface Treatment:	0		
Analysis date:	August 18 2022		Asbestos Type:	1		
Building:	Tenants Hall		<b>Material Score:</b>	<b>3</b>		
Floor level:	Ground Floor		Occupant Activity:	1		
Room:	Hall		Location:	2		
Position:	Floor		Accessibility:	1		
Item Description:	Floor Tile Adhesive		Extent/amount:	2		>130m <sup>2</sup>
Level of Identification:	SAMPLED		Number of Occupants:	0		
<b>Action:</b>	Remove	Frequency of Use:	3			
<b>RISK CODE:</b>	<b>C</b>	Priority Assessment	Time in Area:	1		
			Maintenance activity:	1		
			Frequency of Maintenance:	1		
			<b>Priority Score:</b>	<b>6</b>		
		<b>Total Score:</b>	<b>9</b>			
<b>Comments:</b>	Beneath modern screed

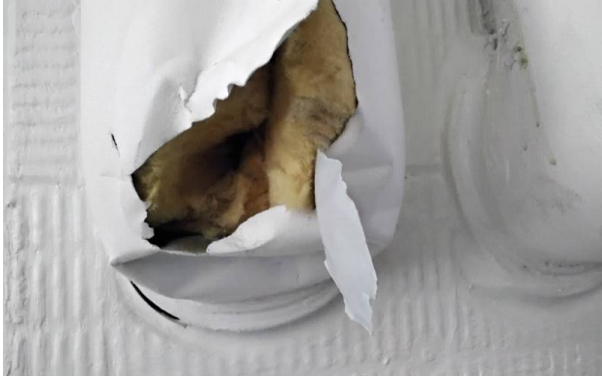
<b>Item / Inspection Ref:</b>	#6	Material Assessment	Product type:

<b>Sample Ref:</b>			Condition / Damage:		
Survey date:	15/08/22 TO 16/08/22		Surface Treatment:		
Analysis date:			Asbestos Type:		
Building:	Tenants Hall		<b>Material Score:</b>		
Floor level:	Ground Floor		Occupant Activity:		
Room:	Hall		Location:		
Position:	Pipework		Accessibility:		
Item Description:	Intrusive Inspection		Extent/amount:		
Level of Identification:	N/A		Number of Occupants:		
<b>Action:</b>		Frequency of Use:			
<b>RISK CODE:</b>	<b>No Asbestos</b>	Priority Assessment	Time in Area:		
			Maintenance activity:		
			Frequency of Maintenance:		
			<b>Priority Score:</b>		
		<b>Total Score:</b>			
<b>Comments:</b>	MMMF insulation to red oxide metal pipework.

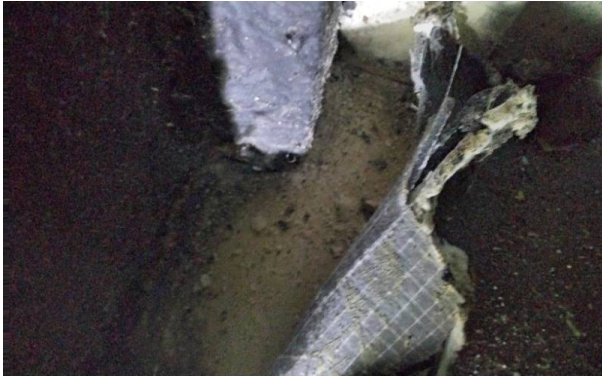
<b>Item / Inspection Ref:</b>	#13	Material Assessment	Product type:	1

<b>Sample Ref:</b>	As Sample SY004166		Condition / Damage:	1			
Survey date:	15/08/22 TO 16/08/22		Surface Treatment:	0			
Analysis date:			Asbestos Type:	1			
Building:	Tenants Hall		<b>Material Score:</b>	<b>3</b>			
Floor level:	Ground Floor		Priority Assessment	Occupant Activity:		1	
Room:	Hallway			Location:		2	
Position:	Floor			Accessibility:		1	
Item Description:	Floor Tile Adhesive			Extent/amount:		2	6m <sup>2</sup>
Level of Identification:	STRONGLY PRESUMED			Number of Occupants:		0	
<b>Action:</b>	Remove	Frequency of Use:		3			
<b>RISK CODE:</b>	C	Time in Area:		1			
		Maintenance activity:		1			
		Frequency of Maintenance:	1				
		<b>Priority Score:</b>	<b>6</b>				
		<b>Total Score:</b>	<b>9</b>				
<b>Comments:</b>	Beneath modern screed

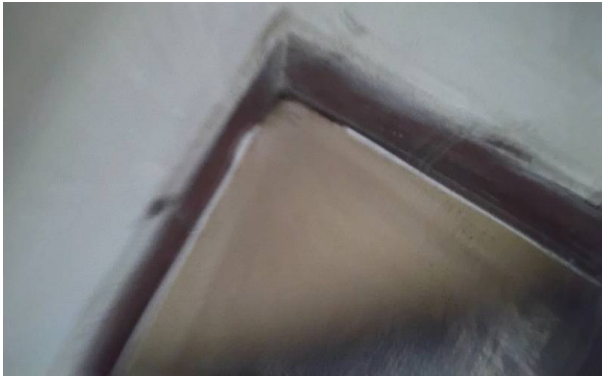
<b>Item / Inspection Ref:</b>	#14	Material Assessment	Product type:	1

<b>Sample Ref:</b>	As Sample SY004166		Condition / Damage:	1			
Survey date:	15/08/22 TO 16/08/22		Surface Treatment:	0			
Analysis date:			Asbestos Type:	1			
Building:	Tenants Hall		<b>Material Score:</b>	<b>3</b>			
Floor level:	Ground Floor		Priority Assessment	Occupant Activity:		1	
Room:	Room 1			Location:		2	
Position:	Floor WC1			Accessibility:		1	
Item Description:	Floor Tile Adhesive			Extent/amount:		2	8m <sup>2</sup>
Level of Identification:	STRONGLY PRESUMED			Number of Occupants:		0	
<b>Action:</b>	Remove	Frequency of Use:		3			
<b>RISK CODE:</b>	C	Time in Area:		1			
		Maintenance activity:		1			
		Frequency of Maintenance:	1				
		<b>Priority Score:</b>	<b>6</b>				
		<b>Total Score:</b>	<b>9</b>				
<b>Comments:</b>	Beneath modern screed

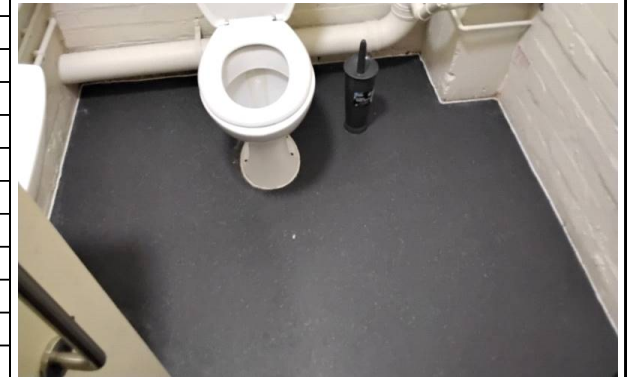
<b>Item / Inspection Ref:</b>	#16	<b>Material Assessment</b>	Product type:	1	
<b>Sample Ref:</b>	As Sample SY004166		Condition / Damage:	1	
Survey date:	15/08/22 TO 16/08/22		Surface Treatment:	0	
Analysis date:			Asbestos Type:	1	
Building:	Tenants Hall		<b>Material Score:</b>	<b>3</b>	
Floor level:	Ground Floor		<b>Priority Assessment</b>	Occupant Activity:	1
Room:	Room 2			Location:	2
Position:	Floor WC2			Accessibility:	1
Item Description:	Floor Tile Adhesive			Extent/amount:	2 6m <sup>2</sup>
Level of Identification:	STRONGLY PRESUMED			Number of Occupants:	0
<b>Action:</b>	Remove	Frequency of Use:		3	
<b>RISK CODE:</b>	<b>C</b>	Time in Area:		1	
		Maintenance activity:		1	
		Frequency of Maintenance:		1	
		<b>Priority Score:</b>		<b>6</b>	
		<b>Total Score:</b>	<b>9</b>		
<b>Comments:</b>	Beneath modern screed

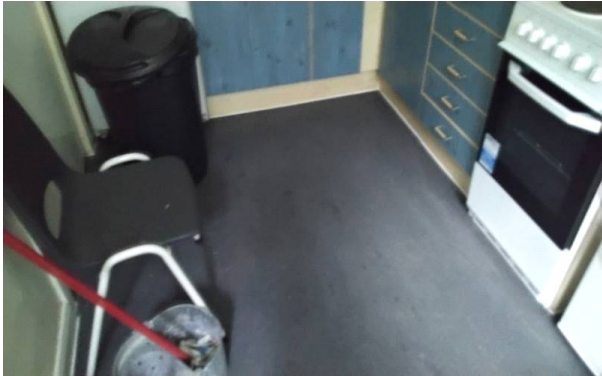
<b>Item / Inspection Ref:</b>	#17	Material Assessment	Product type:	1

<b>Sample Ref:</b>	As Sample SY004166		Condition / Damage:	1			
Survey date:	15/08/22 TO 16/08/22		Surface Treatment:	0			
Analysis date:			Asbestos Type:	1			
Building:	Tenants Hall		<b>Material Score:</b>	<b>3</b>			
Floor level:	Ground Floor		Priority Assessment	Occupant Activity:		1	
Room:	Kitchen			Location:		2	
Position:	Floor			Accessibility:		1	
Item Description:	Floor Tile Adhesive			Extent/amount:		2	8m <sup>2</sup>
Level of Identification:	STRONGLY PRESUMED			Number of Occupants:		0	
<b>Action:</b>	Remove	Frequency of Use:		3			
<b>RISK CODE:</b>	<b>C</b>	Time in Area:		1			
		Maintenance activity:		1			
		Frequency of Maintenance:	1				
		<b>Priority Score:</b>	<b>6</b>				
		<b>Total Score:</b>	<b>9</b>				
<b>Comments:</b>	Beneath modern screed

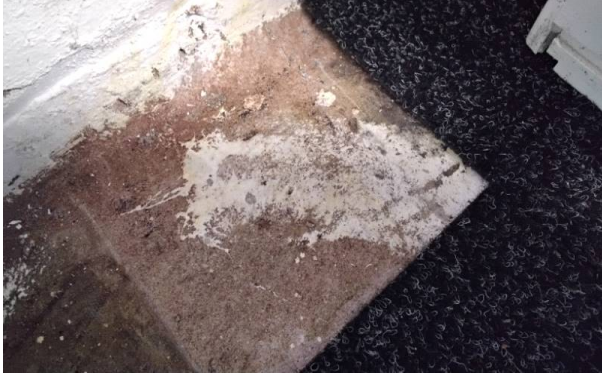
<b>Item / Inspection Ref:</b>	#20	Material Assessment	Product type:	1

<b>Sample Ref:</b>	As Sample SY004166		Condition / Damage:	1		
Survey date:	15/08/22 TO 16/08/22		Surface Treatment:	0		
Analysis date:			Asbestos Type:	1		
Building:	Tenants Hall		<b>Material Score:</b>	<b>3</b>		
Floor level:	Ground Floor		Priority Assessment	Occupant Activity:		1
Room:	Office			Location:		2
Position:	Floor			Accessibility:		1
Item Description:	Floor Tile Adhesive			Extent/amount:		2 20m <sup>2</sup>
Level of Identification:	STRONGLY PRESUMED			Number of Occupants:		0
<b>Action:</b>	Remove	Frequency of Use:		3		
<b>RISK CODE:</b>	<b>C</b>	Time in Area:		1		
		Maintenance activity:		1		
		Frequency of Maintenance:		1		
		<b>Priority Score:</b>		<b>6</b>		
		<b>Total Score:</b>	<b>9</b>			
<b>Comments:</b>	Beneath modern screed

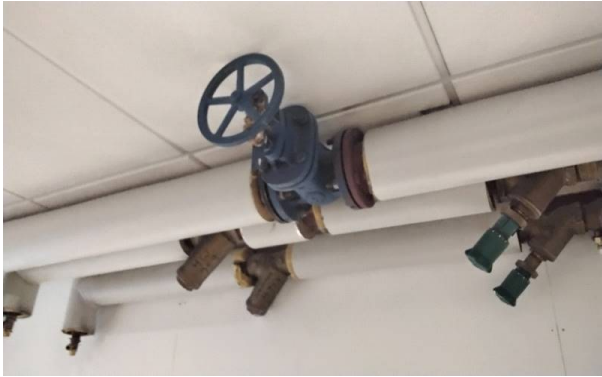
<b>Sample Ref:</b>	As Sample SY004165		Condition / Damage:	1			
Survey date:	15/08/22 TO 16/08/22		Surface Treatment:	2			
Analysis date:			Asbestos Type:	1			
Building:	Tenants Hall		<b>Material Score:</b>	<b>6</b>			
Floor level:	Ground Floor		<b>Priority Assessment</b>	Occupant Activity:		1	
Room:	Office			Location:		2	
Position:	Pipework			Accessibility:		1	
Item Description:	Gasket in pipe and vessel joints - Boiler, Vessels and Pipework			Extent/amount:		1	2no.
Level of Identification:	STRONGLY PRESUMED			Number of Occupants:		0	
<b>Action:</b>	Remove	Frequency of Use:		3			
<b>RISK CODE:</b>	<b>C</b>	Time in Area:		1			
		Maintenance activity:		1			
		Frequency of Maintenance:	1				
		<b>Priority Score:</b>	<b>6</b>				
		<b>Total Score:</b>	<b>12</b>				
<b>Comments:</b>	Gasket

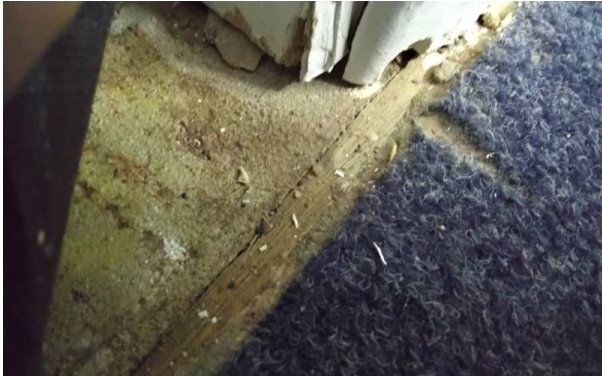
<b>Sample Ref:</b>	As Sample SY004166		Condition / Damage:	1			
Survey date:	15/08/22 TO 16/08/22		Surface Treatment:	0			
Analysis date:			Asbestos Type:	1			
Building:	Tenants Hall		<b>Material Score:</b>	<b>3</b>			
Floor level:	Ground Floor		<b>Priority Assessment</b>	Occupant Activity:		1	
Room:	Office 1			Location:		2	
Position:	Floor			Accessibility:		1	
Item Description:	Floor Tile Adhesive			Extent/amount:		2	25m <sup>2</sup>
Level of Identification:	STRONGLY PRESUMED			Number of Occupants:		0	
<b>Action:</b>	Remove	Frequency of Use:		3			
<b>RISK CODE:</b>	<b>C</b>	Time in Area:		1			
		Maintenance activity:		1			
		Frequency of Maintenance:		1			
		<b>Priority Score:</b>	<b>6</b>				
		<b>Total Score:</b>	<b>9</b>				
<b>Comments:</b>	Beneath modern screed

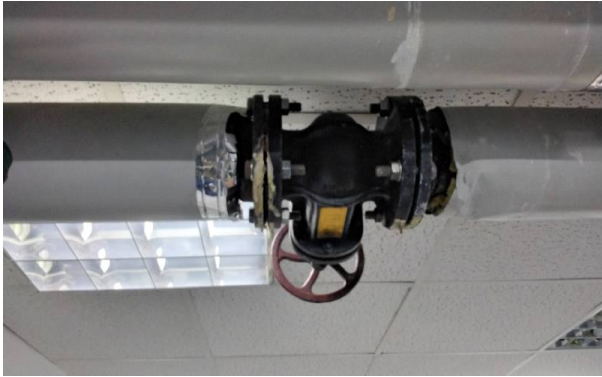
<b>Sample Ref:</b>	As Sample SY004165		Condition / Damage:	1			
Survey date:	15/08/22 TO 16/08/22		Surface Treatment:	2			
Analysis date:			Asbestos Type:	1			
Building:	Tenants Hall		<b>Material Score:</b>	<b>6</b>			
Floor level:	Ground Floor		<b>Priority Assessment</b>	Occupant Activity:		1	
Room:	Office 1			Location:		2	
Position:	Pipework			Accessibility:		1	
Item Description:	Gasket in pipe and vessel joints - Boiler, Vessels and Pipework			Extent/amount:		1	2no.
Level of Identification:	STRONGLY PRESUMED			Number of Occupants:		2	
<b>Action:</b>	Remove	Frequency of Use:		3			
<b>RISK CODE:</b>	<b>B</b>	Time in Area:		2			
		Maintenance activity:		1			
		Frequency of Maintenance:		1			
		<b>Priority Score:</b>		<b>7</b>			
		<b>Total Score:</b>	<b>13</b>				
<b>Comments:</b>	Gasket

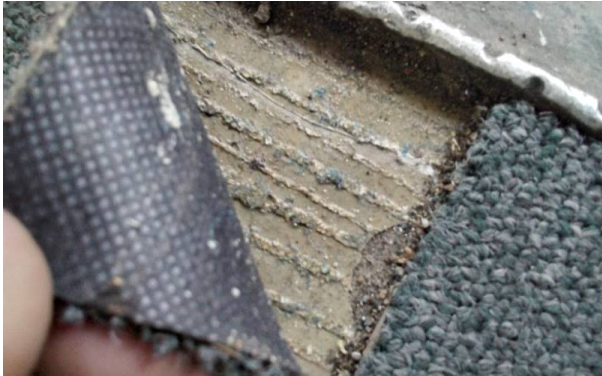
<b>Sample Ref:</b>	As Sample SY004166		Condition / Damage:	1			
Survey date:	15/08/22 TO 16/08/22		Surface Treatment:	0			
Analysis date:			Asbestos Type:	1			
Building:	Tenants Hall		<b>Material Score:</b>	<b>3</b>			
Floor level:	Ground Floor		<b>Priority Assessment</b>	Occupant Activity:		1	
Room:	Corridor 1			Location:		2	
Position:	Floor			Accessibility:		1	
Item Description:	Floor Tile Adhesive			Extent/amount:		1	6m <sup>2</sup>
Level of Identification:	STRONGLY PRESUMED			Number of Occupants:		2	
<b>Action:</b>	Remove	Frequency of Use:		3			
<b>RISK CODE:</b>	<b>C</b>	Time in Area:		2			
		Maintenance activity:		1			
		Frequency of Maintenance:		1			
		<b>Priority Score:</b>		<b>7</b>			
		<b>Total Score:</b>	<b>10</b>				
<b>Comments:</b>	Beneath modern screed

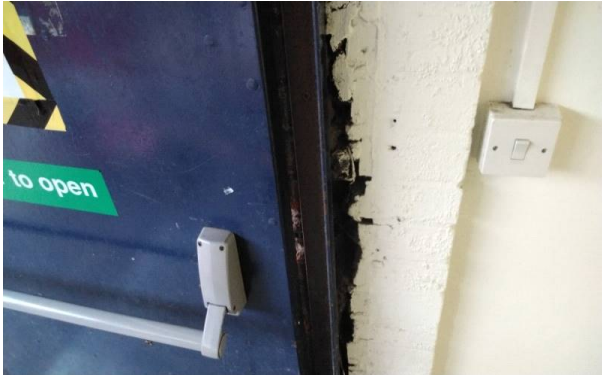
<b>Sample Ref:</b>	SY004177		Condition / Damage:		
Survey date:	15/08/22 TO 16/08/22		Surface Treatment:		
Analysis date:	August 18 2022		Asbestos Type:		
Building:	Tenants Hall		<b>Material Score:</b>		
Floor level:	Ground Floor	<b>Priority Assessment</b>	Occupant Activity:		
Room:	Corridor 1		Location:		
Position:	Door		Accessibility:		
Item Description:	Bitumen		Extent/amount:		
Level of Identification:	SAMPLED		Number of Occupants:		
<b>Action:</b>	None required		Frequency of Use:		
<b>RISK CODE:</b>	<b>No Asbestos</b>		Time in Area:		
			Maintenance activity:		
			Frequency of Maintenance:		
			<b>Priority Score:</b>		
		<b>Total Score:</b>			
<b>Comments:</b>	Bitumen packers - presumed to all doors.

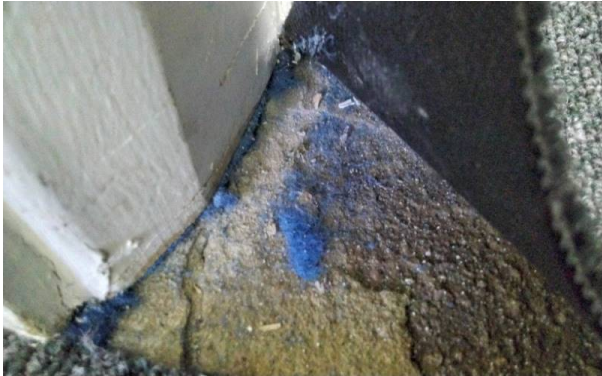
<b>Sample Ref:</b>	As Sample SY004166		Condition / Damage:	1			
Survey date:	15/08/22 TO 16/08/22		Surface Treatment:	0			
Analysis date:			Asbestos Type:	1			
Building:	Tenants Hall		<b>Material Score:</b>	<b>3</b>			
Floor level:	Ground Floor		Priority Assessment	Occupant Activity:		1	
Room:	Room			Location:		2	
Position:	Floor			Accessibility:		1	
Item Description:	Floor Tile Adhesive			Extent/amount:		1	10m <sup>2</sup>
Level of Identification:	STRONGLY PRESUMED			Number of Occupants:		2	
<b>Action:</b>	Remove	Frequency of Use:		3			
<b>RISK CODE:</b>	C	Time in Area:		2			
		Maintenance activity:		1			
		Frequency of Maintenance:		1			
		<b>Priority Score:</b>		<b>7</b>			
		<b>Total Score:</b>	<b>10</b>				
<b>Comments:</b>	Beneath modern screed

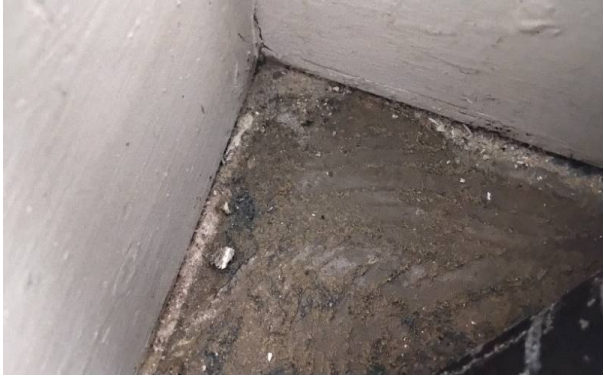
<b>Sample Ref:</b>	As Sample SY004166		Condition / Damage:	1	
Survey date:	15/08/22 TO 16/08/22		Surface Treatment:	0	
Analysis date:			Asbestos Type:	1	
Building:	Tenants Hall		<b>Material Score:</b>	<b>3</b>	
Floor level:	Ground Floor	<b>Priority Assessment</b>	Occupant Activity:	1	
Room:	Office 3		Location:	2	
Position:	Floor		Accessibility:	1	
Item Description:	Floor Tile Adhesive		Extent/amount:	1   30m <sup>2</sup>	
Level of Identification:	STRONGLY PRESUMED		Number of Occupants:	2	
<b>Action:</b>	Remove		Frequency of Use:	3	
<b>RISK CODE:</b>	<b>C</b>		Time in Area:	2	
			Maintenance activity:	1	
		Frequency of Maintenance:	1		
		<b>Priority Score:</b>	<b>7</b>		
		<b>Total Score:</b>	<b>10</b>		
<b>Comments:</b>	Beneath modern screed

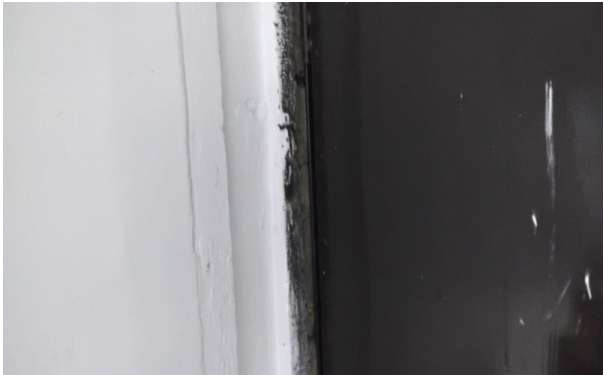
<b>Sample Ref:</b>	As Sample SY004177		Condition / Damage:			
Survey date:	15/08/22 TO 16/08/22		Surface Treatment:			
Analysis date:			Asbestos Type:			
Building:	Tenants Hall		<b>Material Score:</b>			
Floor level:	Ground Floor		Priority Assessment	Occupant Activity:		
Room:	Office 3			Location:		
Position:	Door			Accessibility:		
Item Description:	Bitumen			Extent/amount:		
Level of Identification:	STRONGLY PRESUMED			Number of Occupants:		
<b>Action:</b>	None required	Frequency of Use:				
<b>RISK CODE:</b>	<b>No Asbestos</b>	Time in Area:				
		Maintenance activity:				
		Frequency of Maintenance:				
		<b>Priority Score:</b>				
		<b>Total Score:</b>				
<b>Comments:</b>	Bitumen packers - presumed to all doors.

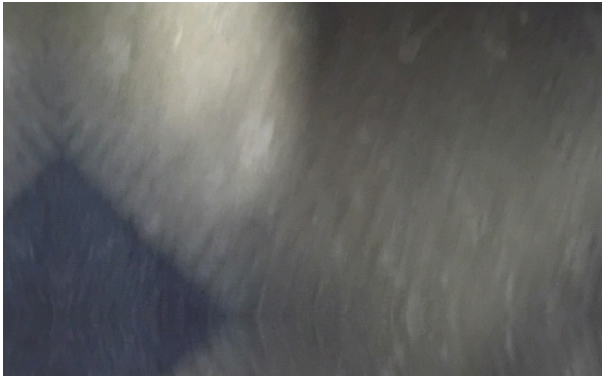
<b>Sample Ref:</b>	As Sample SY004166		Condition / Damage:	1	
Survey date:	15/08/22 TO 16/08/22		Surface Treatment:	0	
Analysis date:			Asbestos Type:	1	
Building:	Tenants Hall		<b>Material Score:</b>	<b>3</b>	
Floor level:	Ground Floor	<b>Priority Assessment</b>	Occupant Activity:	1	
Room:	Office 4		Location:	2	
Position:	Floor		Accessibility:	1	
Item Description:	Floor Tile Adhesive		Extent/amount:	1   10m <sup>2</sup>	
Level of Identification:	STRONGLY PRESUMED		Number of Occupants:	2	
<b>Action:</b>	Remove		Frequency of Use:	3	
<b>RISK CODE:</b>	<b>C</b>		Time in Area:	2	
			Maintenance activity:	1	
			Frequency of Maintenance:	1	
			<b>Priority Score:</b>	<b>7</b>	
<b>Total Score:</b>	<b>10</b>				
<b>Comments:</b>	Beneath modern screed

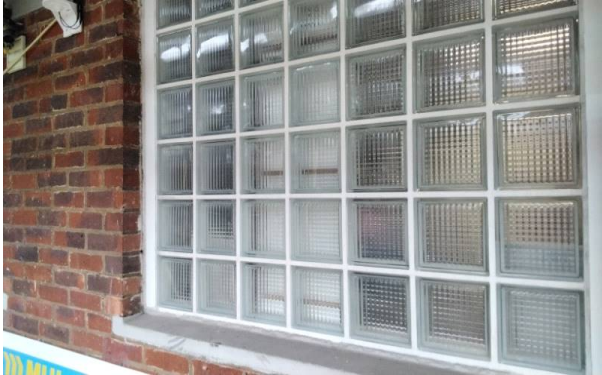
<b>Sample Ref:</b>	SY004178		Condition / Damage:	1		
Survey date:	15/08/22 TO 16/08/22		Surface Treatment:	0		
Analysis date:	August 18 2022		Asbestos Type:	1		
Building:	Tenants Hall		<b>Material Score:</b>	<b>3</b>		
Floor level:	External		Occupant Activity:	1		
Room:	External		Location:	0		
Position:	Windows		Accessibility:	1		
Item Description:	Mastic		Extent/amount:	3		40lm
Level of Identification:	SAMPLED		Number of Occupants:	3		
<b>Action:</b>	Remove	Priority Assessment	Frequency of Use:	3		
<b>RISK CODE:</b>	<b>C</b>		Time in Area:	3		
			Maintenance activity:	1		
			Frequency of Maintenance:	1		
			<b>Priority Score:</b>	<b>7</b>		
			<b>Total Score:</b>	<b>10</b>		
<b>Comments:</b>	All glass block windows have putty around external
