BRUNSWICK SQUARE: DESIRE LINES REPORT

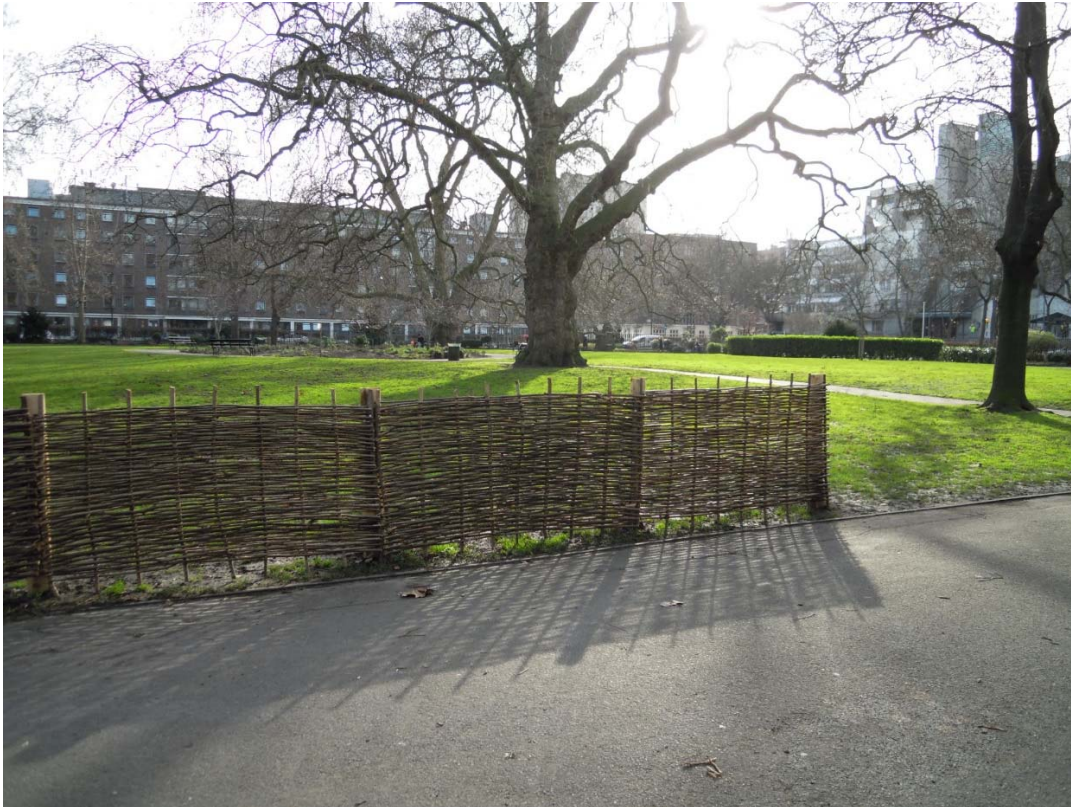
On the date of the observation, temporary willow screening was in place to deter pedestrians from cutting across paths. One screen was placed at the north entrance (Figure 3), one at the south entrance (Figure 4), and another was placed between the south and the west entrance (Figure 4 and 5).

Figure 3: willow screening at north entrance

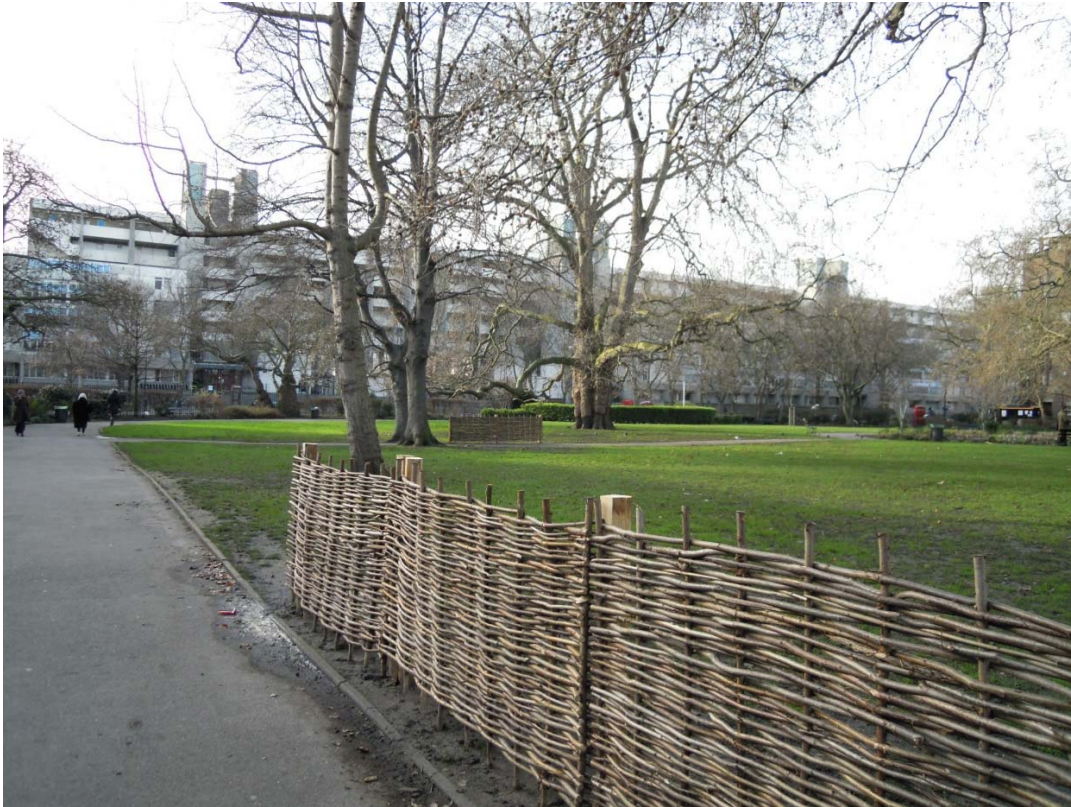
Figure 4: View from south entrance towards west entrance, with two sets of willow screening

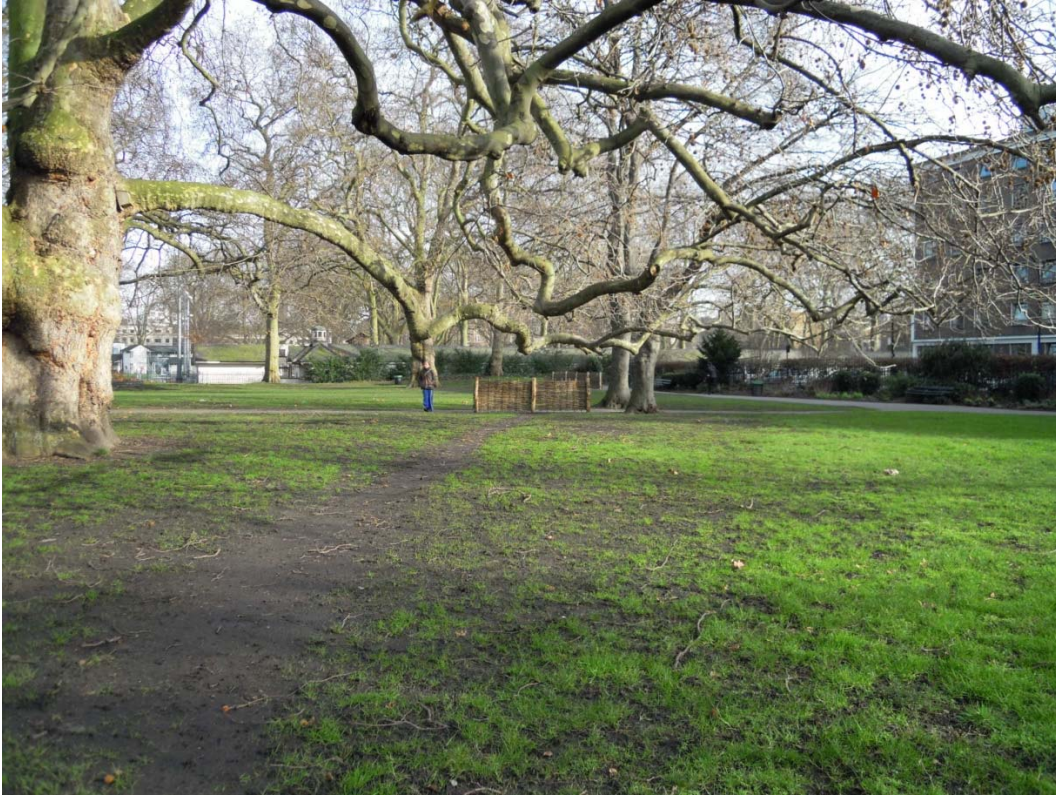
The willow screening may have prevented the observation of natural desire lines through the square, however their placement is indicative of problematic areas, and some desire lines were still visible. An obvious desire line was evident between the south and the west entrance, along the busiest route, shown in Figure 5.

Figure 5: desire line created between west and south entrance, and the willow screening in place to prevent this

The screening did seem to be acting as a deterrent during the observation period, as the volume of people using this route was low (four in two hours). There is a possibility however that pedestrians were deterred from using this route due to the slightly muddy condition of the ground.

The willow screening in place at present is a temporary measure. Although it may be working practically to prevent desire lines, it is not aesthetically in keeping with the character of the square.

We propose a two-part solution to the most problematic desire line between the south and west entrances. Refer to drawing I444_SK_002 for diagram.

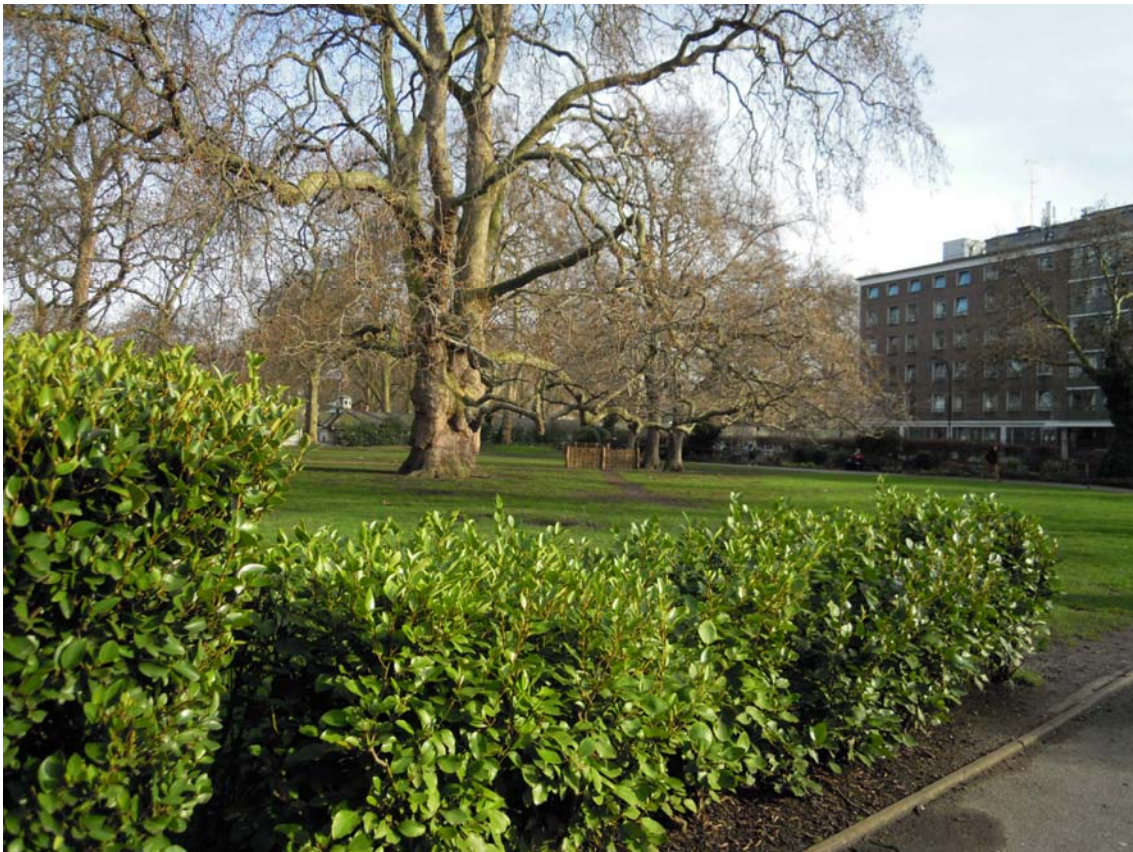
Figure 6: *Griselinia* hedge planting at the west entrance

Firstly we propose that the hedge planting at the west entrance, shown in Figure 6, be extended to keep pedestrians on the path. This could be an extension of the existing *Griselinia*, or it could incorporate more species, for example *Ilex*, which would have an added defensive quality. This hedge would of course have to be protected until it is established and we propose using a post and wire fence, 1.2m high, which would be kept in place for 2-3 years.

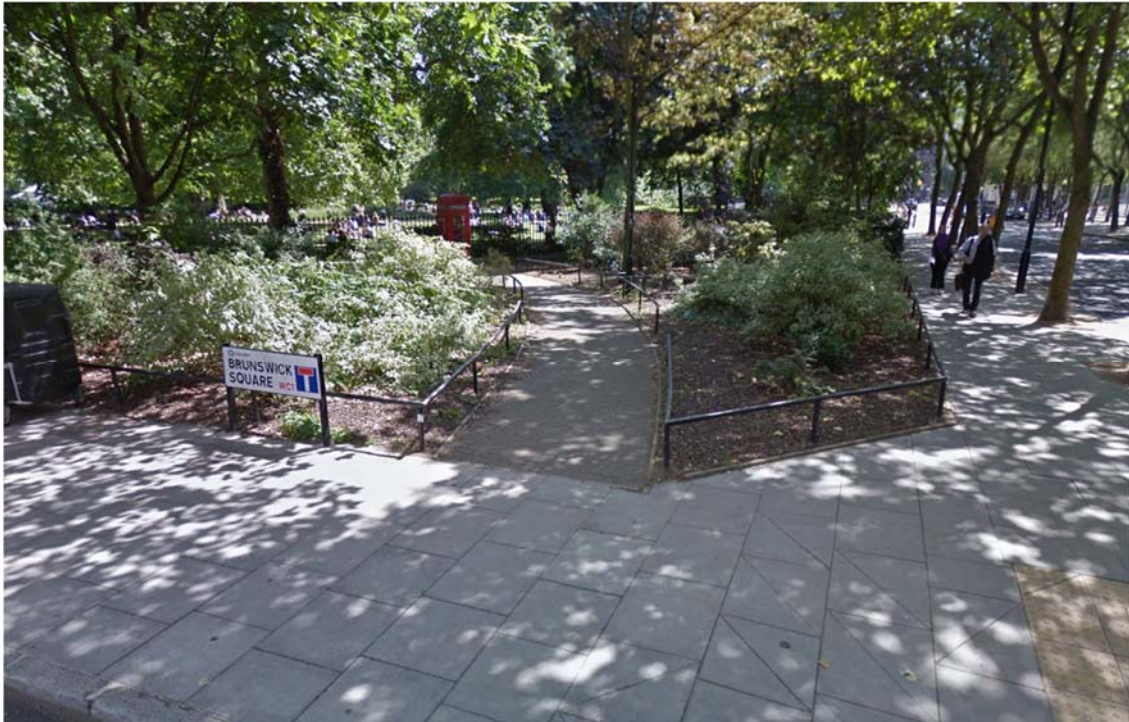
Figure 7: existing knee rails in place outside Brunswick Square

Secondly we propose that a knee rail be installed opposite the south entrance. There are currently metal knee rails in place outside the square, shown in Figure 7, which are protecting shrub planting. A similar style of knee rail could be carried through to the square, or a more traditional Victorian style could be used. We also propose that this railing have planting behind it,

both to reinforce the railing as a barrier, and to reduce the aesthetic impact of the knee rail. This could be either shrub planting or bulb planting. Refer to image sheet I444_SK_003.
