## ASBESTOS REFURBISHMENT SURVEY REPORT

<b>Client</b>	London Borough of Camden
<b>Site</b>	Tenants Hall, Blemundsbury, Dombey Street, London, WC1N 3PF
<b>Date report issued</b>	26th August 2022
<b>Recommended Date for Reinspection</b>	15th August 2023
<b>Survey reference</b>	J765807
<b>Lead surveyor</b>	Kalum Hockley
<b>Assistant surveyor</b>	N/A
<b>UPRN</b>	68839

Tenants Hall, Blemundsbury, Dombey Street, London, WC1N 3PF

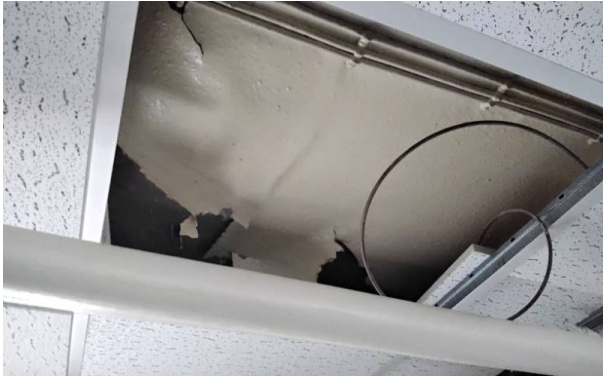
<b>Item / Inspection Ref:</b>	#1	Material Assessment	Product type:

<b>Sample Ref:</b>	SY004162		Condition / Damage:		
Survey date:	15/08/22 TO 16/08/22		Surface Treatment:		
Analysis date:	August 18 2022		Asbestos Type:		
<b>Building:</b>	Tenants Hall		<b>Material Score:</b>		
<b>Floor level:</b>	Ground Floor	Priority Assessment	Occupant Activity:		
<b>Room:</b>	Hall		Location:		
<b>Position:</b>	Ceiling		Accessibility:		
<b>Item Description:</b>	Textured Coating 1		Extent/amount:		
<b>Level of Identification:</b>	SAMPLED		Number of Occupants:		
<b>Action:</b>	None required		Frequency of Use:		
<b>RISK CODE:</b>	<b>No Asbestos</b>		Time in Area:		
			Maintenance activity:		
			Frequency of Maintenance:		
		<b>Priority Score:</b>			
		<b>Total Score:</b>			
<b>Comments:</b>	Behind modern lay in grid ceiling tiles

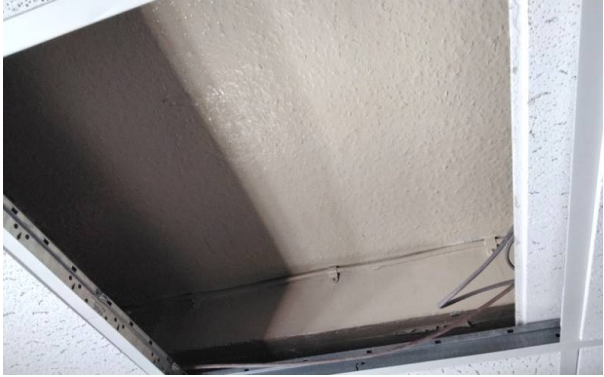
<b>Item / Inspection Ref:</b>	#2	Material Assessment	Product type:

<b>Sample Ref:</b>	SY004163		Condition / Damage:		
Survey date:	15/08/22 TO 16/08/22		Surface Treatment:		
Analysis date:	August 18 2022		Asbestos Type:		
<b>Building:</b>	Tenants Hall		<b>Material Score:</b>		
<b>Floor level:</b>	Ground Floor	Priority Assessment	Occupant Activity:		
<b>Room:</b>	Hall		Location:		
<b>Position:</b>	Ceiling		Accessibility:		
<b>Item Description:</b>	Textured Coating 2		Extent/amount:		
<b>Level of Identification:</b>	SAMPLED		Number of Occupants:		
<b>Action:</b>	None required		Frequency of Use:		
<b>RISK CODE:</b>	<b>No Asbestos</b>		Time in Area:		
			Maintenance activity:		
			Frequency of Maintenance:		
		<b>Priority Score:</b>			
		<b>Total Score:</b>			
<b>Comments:</b>

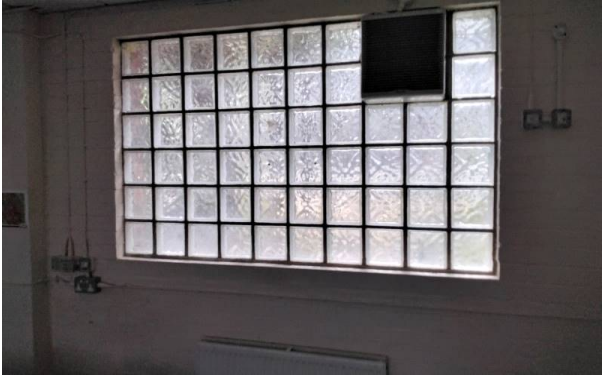
<b>Item / Inspection Ref:</b>	#3	Material Assessment	Product type:		
<b>Sample Ref:</b>	SY004164		Condition / Damage:		
Survey date:	15/08/22 TO 16/08/22		Surface Treatment:		
Analysis date:	August 18 2022		Asbestos Type:		
Building:	Tenants Hall		<b>Material Score:</b>		
Floor level:	Ground Floor		Priority Assessment	Occupant Activity:	
Room:	Hall			Location:	
Position:	Windows			Accessibility:	
Item Description:	Mastic			Extent/amount:	
Level of Identification:	SAMPLED			Number of Occupants:	
<b>Action:</b>	None required	Frequency of Use:			
<b>RISK CODE:</b>	<b>No Asbestos</b>	Time in Area:			
		Maintenance activity:			
		Frequency of Maintenance:			
		<b>Priority Score:</b>			
		<b>Total Score:</b>			
<b>Comments:</b>

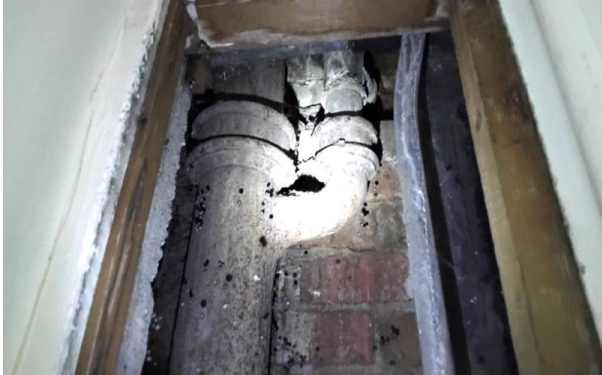
<b>Item / Inspection Ref:</b>	#7	Material Assessment	Product type:

<b>Sample Ref:</b>			Condition / Damage:		
Survey date:	15/08/22 TO 16/08/22		Surface Treatment:		
Analysis date:			Asbestos Type:		
Building:	Tenants Hall		<b>Material Score:</b>		
Floor level:	Ground Floor		Occupant Activity:		
Room:	Hall		Location:		
Position:	Wall		Accessibility:		
Item Description:	Intrusive Inspection		Extent/amount:		
Level of Identification:	N/A		Number of Occupants:		
<b>Action:</b>		Priority Assessment	Frequency of Use:		
<b>RISK CODE:</b>	<b>No Asbestos</b>		Time in Area:		
			Maintenance activity:		
			Frequency of Maintenance:		
			<b>Priority Score:</b>		
<b>Total Score:</b>					
<b>Comments:</b>	Timber boxing housing cast soil pipe.

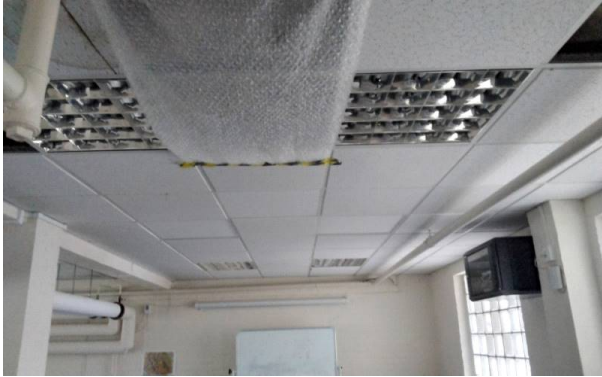
<b>Item / Inspection Ref:</b>	#8	Material Assessment	Product type:

<b>Sample Ref:</b>	SY004167		Condition / Damage:		
Survey date:	15/08/22 TO 16/08/22		Surface Treatment:		
Analysis date:	August 18 2022		Asbestos Type:		
Building:	Tenants Hall		<b>Material Score:</b>		
Floor level:	Ground Floor		Occupant Activity:		
Room:	Hall		Location:		
Position:	Ceiling		Accessibility:		
Item Description:	Unknown - Ceilings		Extent/amount:		
Level of Identification:	SAMPLED		Number of Occupants:		
<b>Action:</b>	None required	Priority Assessment	Frequency of Use:		
<b>RISK CODE:</b>	<b>No Asbestos</b>		Time in Area:		
			Maintenance activity:		
			Frequency of Maintenance:		
			<b>Priority Score:</b>		
<b>Total Score:</b>					
<b>Comments:</b>	Grid tiles

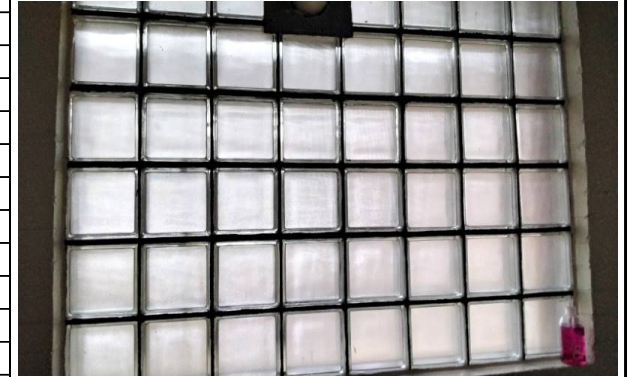
<b>Item / Inspection Ref:</b>	#15	<b>Material Assessment</b>	Product type:		
<b>Sample Ref:</b>	As Sample SY004164		Condition / Damage:		
Survey date:	15/08/22 TO 16/08/22		Surface Treatment:		
Analysis date:			Asbestos Type:		
Building:	Tenants Hall		<b>Material Score:</b>		
Floor level:	Ground Floor		<b>Priority Assessment</b>	Occupant Activity:	
Room:	Room 1			Location:	
Position:	Windows WC1			Accessibility:	
Item Description:	Mastic			Extent/amount:	
Level of Identification:	STRONGLY PRESUMED			Number of Occupants:	
<b>Action:</b>	None required	Frequency of Use:			
<b>RISK CODE:</b>	<b>No Asbestos</b>	Time in Area:			
		Maintenance activity:			
		Frequency of Maintenance:			
		<b>Priority Score:</b>			
		<b>Total Score:</b>			
<b>Comments:</b>

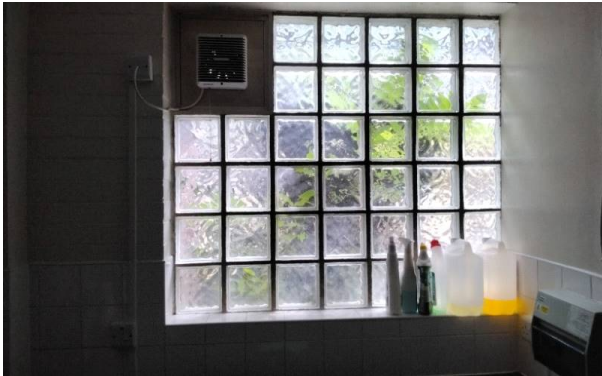
<b>Item / Inspection Ref:</b>	#18	Material Assessment	Product type:

<b>Sample Ref:</b>	As Sample SY004164		Condition / Damage:		
Survey date:	15/08/22 TO 16/08/22		Surface Treatment:		
Analysis date:			Asbestos Type:		
Building:	Tenants Hall		<b>Material Score:</b>		
Floor level:	Ground Floor	Priority Assessment	Occupant Activity:		
Room:	Kitchen		Location:		
Position:	Windows		Accessibility:		
Item Description:	Mastic		Extent/amount:		
Level of Identification:	STRONGLY PRESUMED		Number of Occupants:		
<b>Action:</b>	None required		Frequency of Use:		
<b>RISK CODE:</b>	<b>No Asbestos</b>		Time in Area:		
			Maintenance activity:		
		Frequency of Maintenance:			
		<b>Priority Score:</b>			
		<b>Total Score:</b>			
<b>Comments:</b>

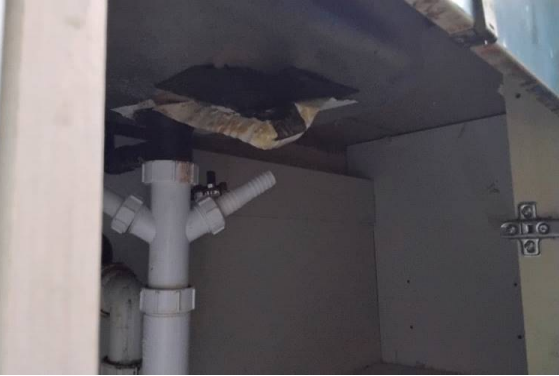
<b>Item / Inspection Ref:</b>	#19	Material Assessment	Product type:

<b>Sample Ref:</b>	SY004168		Condition / Damage:			
Survey date:	15/08/22 TO 16/08/22		Surface Treatment:			
Analysis date:	August 18 2022		Asbestos Type:			
Building:	Tenants Hall		<b>Material Score:</b>			
Floor level:	Ground Floor		Priority Assessment	Occupant Activity:		
Room:	Kitchen			Location:		
Position:	Sink			Accessibility:		
Item Description:	Sink pad			Extent/amount:		
Level of Identification:	SAMPLED			Number of Occupants:		
<b>Action:</b>	None required	Frequency of Use:				
<b>RISK CODE:</b>	<b>No Asbestos</b>	Time in Area:				
		Maintenance activity:				
		Frequency of Maintenance:				
		<b>Priority Score:</b>				
		<b>Total Score:</b>				
<b>Comments:</b>

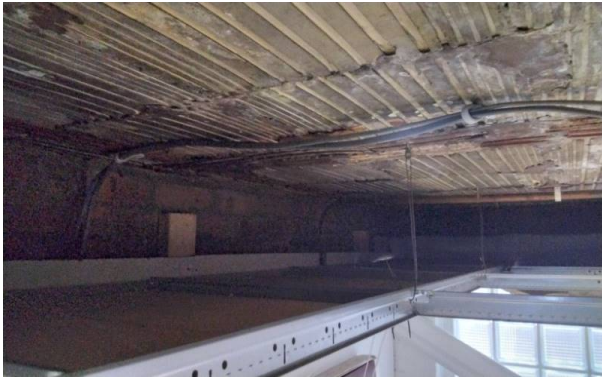
<b>Item / Inspection Ref:</b>	#22	<b>Material Assessment</b>	Product type:

<b>Sample Ref:</b>			Condition / Damage:		
Survey date:	15/08/22 TO 16/08/22		Surface Treatment:		
Analysis date:			Asbestos Type:		
Building:	Tenants Hall		<b>Material Score:</b>		
Floor level:	Ground Floor	<b>Priority Assessment</b>	Occupant Activity:		
Room:	Office		Location:		
Position:	Ceiling		Accessibility:		
Item Description:	Visual Inspection		Extent/amount:		
Level of Identification:	N/A		Number of Occupants:		
<b>Action:</b>			Frequency of Use:		
<b>RISK CODE:</b>	<b>No Asbestos</b>		Time in Area:		
			Maintenance activity:		
		Frequency of Maintenance:			
		<b>Priority Score:</b>			
		<b>Total Score:</b>			
<b>Comments:</b>	Ceiling Void

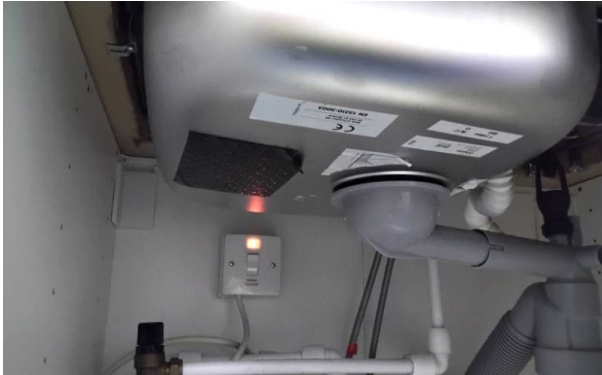
<b>Item / Inspection Ref:</b>	#24	<b>Material Assessment</b>	Product type:

<b>Sample Ref:</b>	SY004176		Condition / Damage:			
Survey date:	15/08/22 TO 16/08/22		Surface Treatment:			
Analysis date:	August 18 2022		Asbestos Type:			
Building:	Tenants Hall		<b>Material Score:</b>			
Floor level:	Ground Floor		<b>Priority Assessment</b>	Occupant Activity:		
Room:	Office 1			Location:		
Position:	Sink			Accessibility:		
Item Description:	Sink pad			Extent/amount:		
Level of Identification:	SAMPLED			Number of Occupants:		
<b>Action:</b>	None required	Frequency of Use:				
<b>RISK CODE:</b>	<b>No Asbestos</b>	Time in Area:				
		Maintenance activity:				
		Frequency of Maintenance:				
		<b>Priority Score:</b>				
		<b>Total Score:</b>				
<b>Comments:</b>

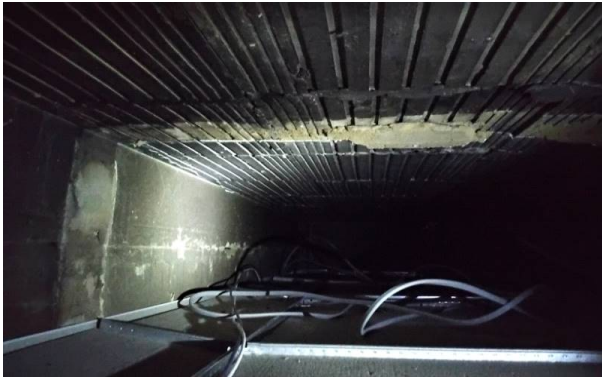
<b>Item / Inspection Ref:</b>	#26	<b>Material Assessment</b>	Product type:

<b>Sample Ref:</b>			Condition / Damage:			
Survey date:	15/08/22 TO 16/08/22		Surface Treatment:			
Analysis date:			Asbestos Type:			
Building:	Tenants Hall		<b>Material Score:</b>			
Floor level:	Ground Floor		<b>Priority Assessment</b>	Occupant Activity:		
Room:	Office 1			Location:		
Position:	Ceiling			Accessibility:		
Item Description:	Visual Inspection			Extent/amount:		
Level of Identification:	N/A			Number of Occupants:		
<b>Action:</b>		Frequency of Use:				
<b>RISK CODE:</b>	<b>No Asbestos</b>	Time in Area:				
		Maintenance activity:				
		Frequency of Maintenance:				
		<b>Priority Score:</b>				
		<b>Total Score:</b>				
<b>Comments:</b>	Ceiling Void

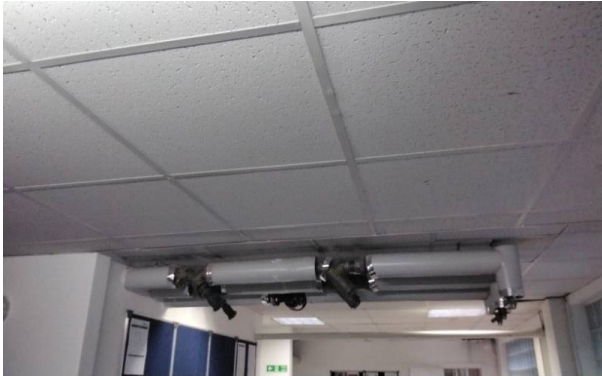
<b>Item / Inspection Ref:</b>	#27	Material Assessment	Product type:

<b>Sample Ref:</b>	As Sample SY004167		Condition / Damage:		
Survey date:	15/08/22 TO 16/08/22		Surface Treatment:		
Analysis date:			Asbestos Type:		
Building:	Tenants Hall		<b>Material Score:</b>		
Floor level:	Ground Floor		Occupant Activity:		
Room:	Office 1		Location:		
Position:	Ceiling		Accessibility:		
Item Description:	Unknown - Ceilings		Extent/amount:		
Level of Identification:	STRONGLY PRESUMED		Number of Occupants:		
<b>Action:</b>	None required	Frequency of Use:			
<b>RISK CODE:</b>	<b>No Asbestos</b>	Priority Assessment	Time in Area:		
			Maintenance activity:		
			Frequency of Maintenance:		
		<b>Priority Score:</b>			
		<b>Total Score:</b>			
<b>Comments:</b>	Grid tiles

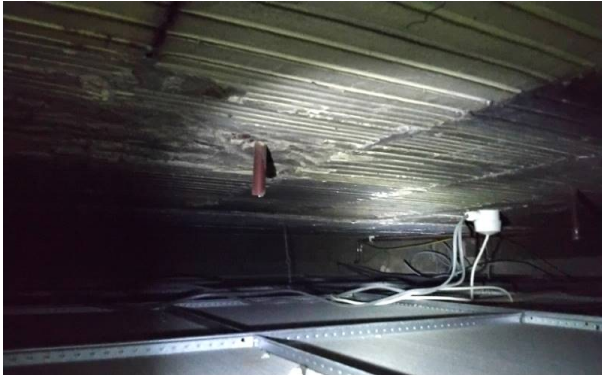
<b>Item / Inspection Ref:</b>	#28	Material Assessment	Product type:

<b>Sample Ref:</b>			Condition / Damage:		
Survey date:	15/08/22 TO 16/08/22		Surface Treatment:		
Analysis date:			Asbestos Type:		
Building:	Tenants Hall		<b>Material Score:</b>		
Floor level:	Ground Floor		Occupant Activity:		
Room:	Office 2		Location:		
Position:	Ceiling		Accessibility:		
Item Description:	Visual Inspection		Extent/amount:		
Level of Identification:	N/A		Number of Occupants:		
<b>Action:</b>		Frequency of Use:			
<b>RISK CODE:</b>	<b>No Asbestos</b>	Priority Assessment	Time in Area:		
			Maintenance activity:		
			Frequency of Maintenance:		
		<b>Priority Score:</b>			
		<b>Total Score:</b>			
<b>Comments:</b>	Ceiling Void

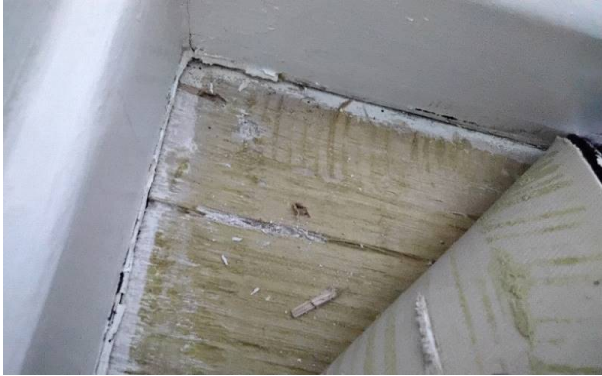
<b>Item / Inspection Ref:</b>	#29	Material Assessment	Product type:

<b>Sample Ref:</b>			Condition / Damage:		
Survey date:	15/08/22 TO 16/08/22		Surface Treatment:		
Analysis date:			Asbestos Type:		
Building:	Tenants Hall		<b>Material Score:</b>		
Floor level:	Ground Floor		Occupant Activity:		
Room:	Office 2		Location:		
Position:	Floor		Accessibility:		
Item Description:	Visual Inspection		Extent/amount:		
Level of Identification:	N/A		Number of Occupants:		
<b>Action:</b>		Priority Assessment	Frequency of Use:		
<b>RISK CODE:</b>	<b>No Asbestos</b>		Time in Area:		
			Maintenance activity:		
			Frequency of Maintenance:		
			<b>Priority Score:</b>		
<b>Comments:</b>	Carpet tile to vinyl to timber primary floor		<b>Total Score:</b>

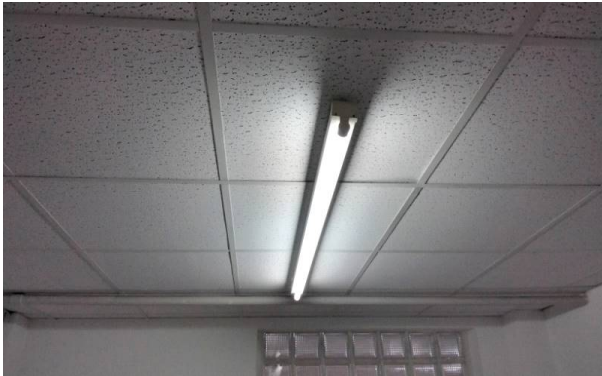
<b>Item / Inspection Ref:</b>	#30	Material Assessment	Product type:

<b>Sample Ref:</b>	As Sample SY004167		Condition / Damage:		
Survey date:	15/08/22 TO 16/08/22		Surface Treatment:		
Analysis date:			Asbestos Type:		
Building:	Tenants Hall		<b>Material Score:</b>		
Floor level:	Ground Floor		Occupant Activity:		
Room:	Office 2		Location:		
Position:	Ceiling		Accessibility:		
Item Description:	Unknown - Ceilings		Extent/amount:		
Level of Identification:	STRONGLY PRESUMED		Number of Occupants:		
<b>Action:</b>	None required	Priority Assessment	Frequency of Use:		
<b>RISK CODE:</b>	<b>No Asbestos</b>		Time in Area:		
			Maintenance activity:		
			Frequency of Maintenance:		
			<b>Priority Score:</b>		
<b>Comments:</b>	Grid tiles		<b>Total Score:</b>

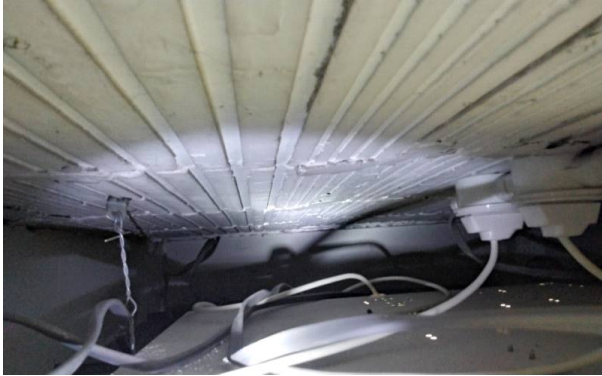
<b>Item / Inspection Ref:</b>	#31	Material Assessment	Product type:

<b>Sample Ref:</b>			Condition / Damage:			
Survey date:	15/08/22 TO 16/08/22		Surface Treatment:			
Analysis date:			Asbestos Type:			
Building:	Tenants Hall		<b>Material Score:</b>			
Floor level:	Ground Floor		Priority Assessment	Occupant Activity:		
Room:	Corridor 1			Location:		
Position:	Ceiling			Accessibility:		
Item Description:	Visual Inspection			Extent/amount:		
Level of Identification:	N/A			Number of Occupants:		
<b>Action:</b>		Frequency of Use:				
<b>RISK CODE:</b>	<b>No Asbestos</b>	Time in Area:				
		Maintenance activity:				
		Frequency of Maintenance:				
		<b>Priority Score:</b>				
		<b>Total Score:</b>				
<b>Comments:</b>	Ceiling Void

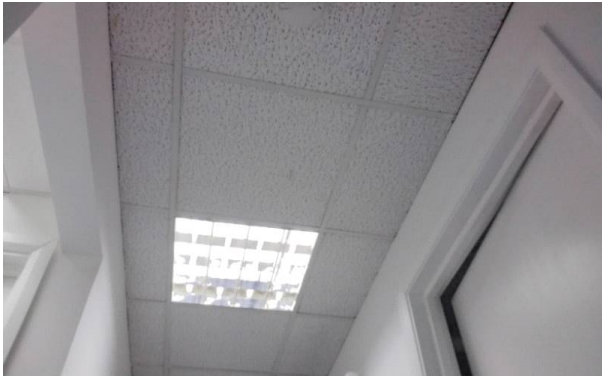
<b>Item / Inspection Ref:</b>	#33	Material Assessment	Product type:

<b>Sample Ref:</b>	As Sample SY004167		Condition / Damage:			
Survey date:	15/08/22 TO 16/08/22		Surface Treatment:			
Analysis date:			Asbestos Type:			
Building:	Tenants Hall		<b>Material Score:</b>			
Floor level:	Ground Floor		Priority Assessment	Occupant Activity:		
Room:	Corridor 1			Location:		
Position:	Ceiling			Accessibility:		
Item Description:	Unknown - Ceilings			Extent/amount:		
Level of Identification:	STRONGLY PRESUMED			Number of Occupants:		
<b>Action:</b>	None required	Frequency of Use:				
<b>RISK CODE:</b>	<b>No Asbestos</b>	Time in Area:				
		Maintenance activity:				
		Frequency of Maintenance:				
		<b>Priority Score:</b>				
		<b>Total Score:</b>				
<b>Comments:</b>	Grid tiles

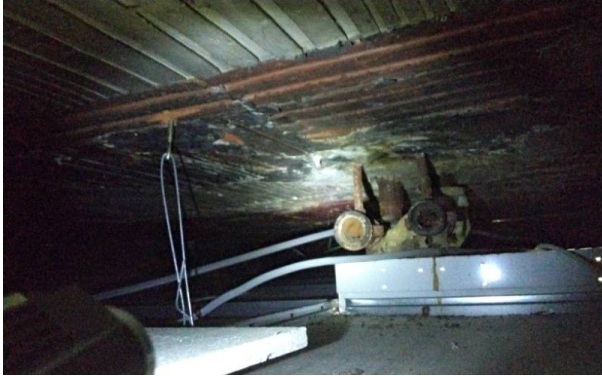
<b>Item / Inspection Ref:</b>	#36	Material Assessment	Product type:

<b>Sample Ref:</b>			Condition / Damage:		
Survey date:	15/08/22 TO 16/08/22		Surface Treatment:		
Analysis date:			Asbestos Type:		
Building:	Tenants Hall		<b>Material Score:</b>		
Floor level:	Ground Floor		Occupant Activity:		
Room:	Room		Location:		
Position:	Ceiling		Accessibility:		
Item Description:	Visual Inspection		Extent/amount:		
Level of Identification:	N/A		Number of Occupants:		
<b>Action:</b>		Priority Assessment	Frequency of Use:		
<b>RISK CODE:</b>	<b>No Asbestos</b>		Time in Area:		
			Maintenance activity:		
			Frequency of Maintenance:		
			<b>Priority Score:</b>		
		<b>Total Score:</b>			
<b>Comments:</b>	Ceiling Void

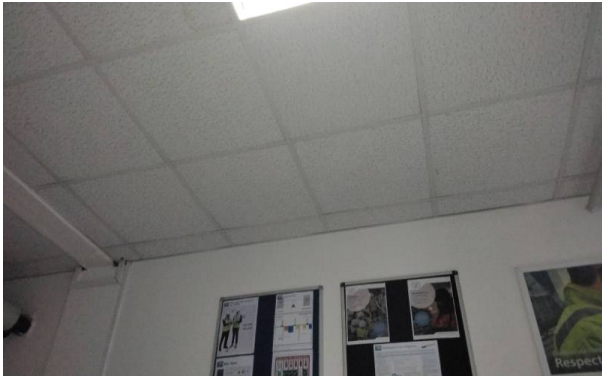
<b>Item / Inspection Ref:</b>	#38	Material Assessment	Product type:

<b>Sample Ref:</b>	As Sample SY004167		Condition / Damage:		
Survey date:	15/08/22 TO 16/08/22		Surface Treatment:		
Analysis date:			Asbestos Type:		
Building:	Tenants Hall		<b>Material Score:</b>		
Floor level:	Ground Floor		Occupant Activity:		
Room:	Room		Location:		
Position:	Ceiling		Accessibility:		
Item Description:	Unknown - Ceilings		Extent/amount:		
Level of Identification:	STRONGLY PRESUMED		Number of Occupants:		
<b>Action:</b>	None required	Priority Assessment	Frequency of Use:		
<b>RISK CODE:</b>	<b>No Asbestos</b>		Time in Area:		
			Maintenance activity:		
			Frequency of Maintenance:		
			<b>Priority Score:</b>		
		<b>Total Score:</b>			
<b>Comments:</b>	Grid tiles

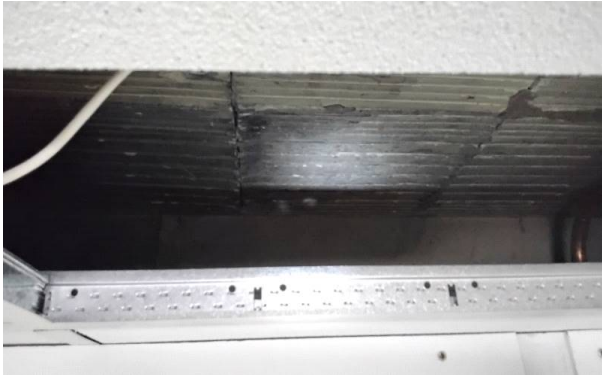
<b>Item / Inspection Ref:</b>	#40	Material Assessment	Product type:

<b>Sample Ref:</b>			Condition / Damage:			
Survey date:	15/08/22 TO 16/08/22		Surface Treatment:			
Analysis date:			Asbestos Type:			
Building:	Tenants Hall		<b>Material Score:</b>			
Floor level:	Ground Floor		Priority Assessment	Occupant Activity:		
Room:	WC			Location:		
Position:	Ceiling			Accessibility:		
Item Description:	Visual Inspection			Extent/amount:		
Level of Identification:	N/A			Number of Occupants:		
<b>Action:</b>		Frequency of Use:				
<b>RISK CODE:</b>	No Asbestos	Time in Area:				
		Maintenance activity:				
		Frequency of Maintenance:				
		<b>Priority Score:</b>				
		<b>Total Score:</b>				
<b>Comments:</b>	Ceiling Void

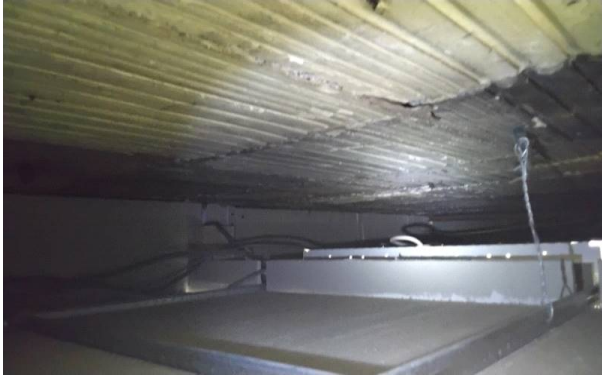
<b>Item / Inspection Ref:</b>	#41	Material Assessment	Product type:

<b>Sample Ref:</b>			Condition / Damage:		
Survey date:	15/08/22 TO 16/08/22		Surface Treatment:		
Analysis date:			Asbestos Type:		
Building:	Tenants Hall		<b>Material Score:</b>		
Floor level:	Ground Floor		Occupant Activity:		
Room:	WC1		Location:		
Position:	Ceiling		Accessibility:		
Item Description:	Visual Inspection		Extent/amount:		
Level of Identification:	N/A		Number of Occupants:		
<b>Action:</b>		Priority Assessment	Frequency of Use:		
<b>RISK CODE:</b>	<b>No Asbestos</b>		Time in Area:		
			Maintenance activity:		
			Frequency of Maintenance:		
			<b>Priority Score:</b>		
		<b>Total Score:</b>			
<b>Comments:</b>	Ceiling Void

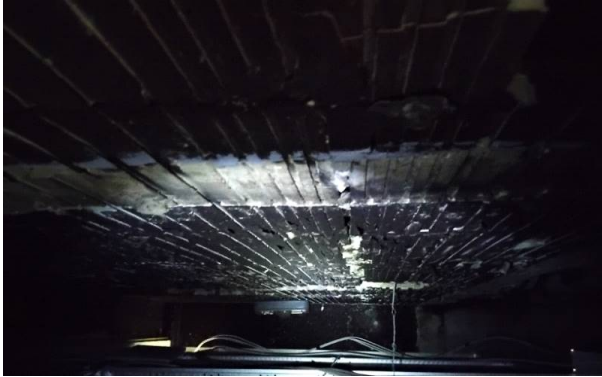
<b>Item / Inspection Ref:</b>	#42	Material Assessment	Product type:

<b>Sample Ref:</b>			Condition / Damage:		
Survey date:	15/08/22 TO 16/08/22		Surface Treatment:		
Analysis date:			Asbestos Type:		
Building:	Tenants Hall		<b>Material Score:</b>		
Floor level:	Ground Floor		Occupant Activity:		
Room:	Office 3		Location:		
Position:	Ceiling		Accessibility:		
Item Description:	Visual Inspection		Extent/amount:		
Level of Identification:	N/A		Number of Occupants:		
<b>Action:</b>		Priority Assessment	Frequency of Use:		
<b>RISK CODE:</b>	<b>No Asbestos</b>		Time in Area:		
			Maintenance activity:		
			Frequency of Maintenance:		
			<b>Priority Score:</b>		
		<b>Total Score:</b>			
<b>Comments:</b>	Ceiling Void

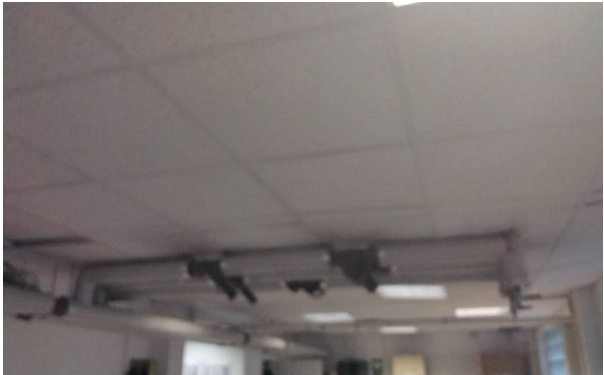
<b>Item / Inspection Ref:</b>	#43	<b>Material Assessment</b>	Product type:

<b>Sample Ref:</b>	As Sample SY004167		Condition / Damage:			
Survey date:	15/08/22 TO 16/08/22		Surface Treatment:			
Analysis date:			Asbestos Type:			
Building:	Tenants Hall		<b>Material Score:</b>			
Floor level:	Ground Floor		<b>Priority Assessment</b>	Occupant Activity:		
Room:	Office 3			Location:		
Position:	Ceiling			Accessibility:		
Item Description:	Unknown - Ceilings			Extent/amount:		
Level of Identification:	STRONGLY PRESUMED			Number of Occupants:		
<b>Action:</b>	None required	Frequency of Use:				
<b>RISK CODE:</b>	<b>No Asbestos</b>	Time in Area:				
		Maintenance activity:				
		Frequency of Maintenance:				
		<b>Priority Score:</b>				
		<b>Total Score:</b>				
<b>Comments:</b>	Grid tiles

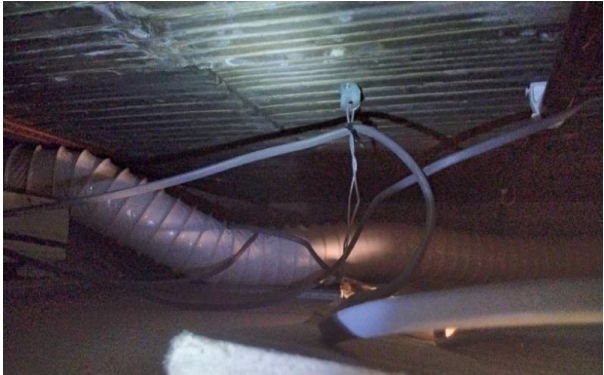
<b>Item / Inspection Ref:</b>	#46	Material Assessment	Product type:

<b>Sample Ref:</b>			Condition / Damage:		
Survey date:	15/08/22 TO 16/08/22		Surface Treatment:		
Analysis date:			Asbestos Type:		
Building:	Tenants Hall		<b>Material Score:</b>		
Floor level:	Ground Floor	Priority Assessment	Occupant Activity:		
Room:	WC2		Location:		
Position:	Ceiling		Accessibility:		
Item Description:	Visual Inspection		Extent/amount:		
Level of Identification:	N/A		Number of Occupants:		
<b>Action:</b>			Frequency of Use:		
<b>RISK CODE:</b>	<b>No Asbestos</b>		Time in Area:		
			Maintenance activity:		
		Frequency of Maintenance:			
		<b>Priority Score:</b>			
		<b>Total Score:</b>			
<b>Comments:</b>	Ceiling Void

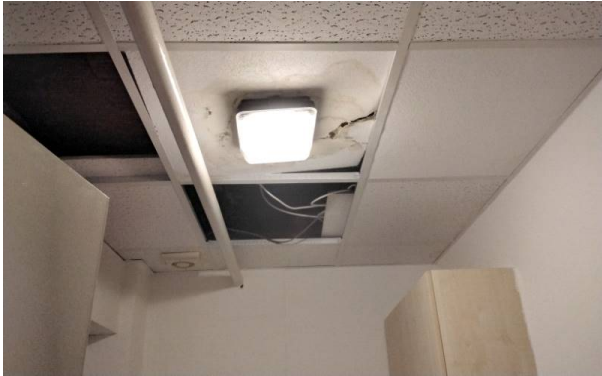
<b>Item / Inspection Ref:</b>	#47	Material Assessment	Product type:

<b>Sample Ref:</b>	As Sample SY004167		Condition / Damage:		
Survey date:	15/08/22 TO 16/08/22		Surface Treatment:		
Analysis date:			Asbestos Type:		
Building:	Tenants Hall		<b>Material Score:</b>		
Floor level:	Ground Floor		Occupant Activity:		
Room:	WC2		Location:		
Position:	Ceiling		Accessibility:		
Item Description:	Unknown - Ceilings		Extent/amount:		
Level of Identification:	STRONGLY PRESUMED		Number of Occupants:		
<b>Action:</b>	None required	Priority Assessment	Frequency of Use:		
<b>RISK CODE:</b>	<b>No Asbestos</b>		Time in Area:		
			Maintenance activity:		
			Frequency of Maintenance:		
			<b>Priority Score:</b>		
		<b>Total Score:</b>			
<b>Comments:</b>	Grid tiles

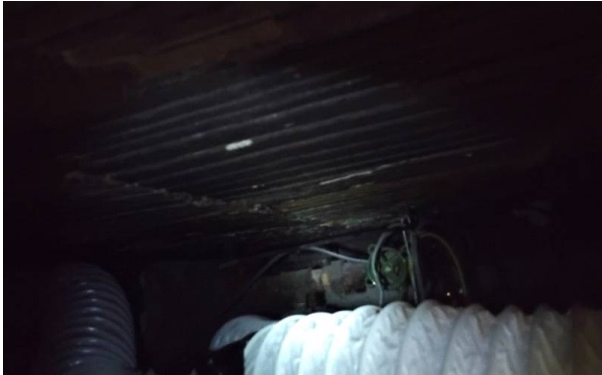
<b>Item / Inspection Ref:</b>	#48	Material Assessment	Product type:

<b>Sample Ref:</b>			Condition / Damage:		
Survey date:	15/08/22 TO 16/08/22		Surface Treatment:		
Analysis date:			Asbestos Type:		
Building:	Tenants Hall		<b>Material Score:</b>		
Floor level:	Ground Floor		Occupant Activity:		
Room:	WC3		Location:		
Position:	Ceiling		Accessibility:		
Item Description:	Visual Inspection		Extent/amount:		
Level of Identification:	N/A		Number of Occupants:		
<b>Action:</b>		Priority Assessment	Frequency of Use:		
<b>RISK CODE:</b>	<b>No Asbestos</b>		Time in Area:		
			Maintenance activity:		
			Frequency of Maintenance:		
			<b>Priority Score:</b>		
		<b>Total Score:</b>			
<b>Comments:</b>	Ceiling Void

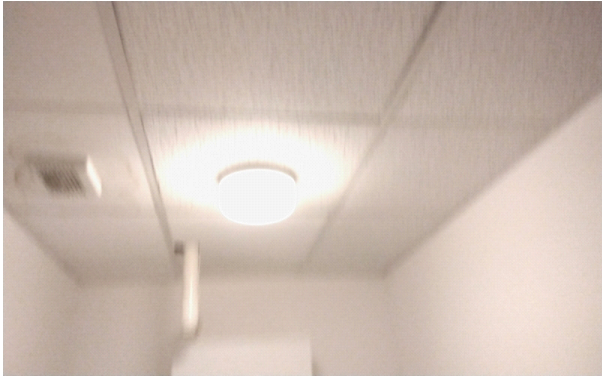
<b>Item / Inspection Ref:</b>	#49	Material Assessment	Product type:

<b>Sample Ref:</b>	As Sample SY004167		Condition / Damage:		
Survey date:	15/08/22 TO 16/08/22		Surface Treatment:		
Analysis date:			Asbestos Type:		
Building:	Tenants Hall		<b>Material Score:</b>		
Floor level:	Ground Floor		Occupant Activity:		
Room:	WC3		Location:		
Position:	Ceiling		Accessibility:		
Item Description:	Unknown - Ceilings		Extent/amount:		
Level of Identification:	STRONGLY PRESUMED		Number of Occupants:		
<b>Action:</b>	None required	Frequency of Use:			
<b>RISK CODE:</b>	<b>No Asbestos</b>	Priority Assessment	Time in Area:		
			Maintenance activity:		
			Frequency of Maintenance:		
			<b>Priority Score:</b>		
<b>Total Score:</b>					
<b>Comments:</b>	Grid tiles

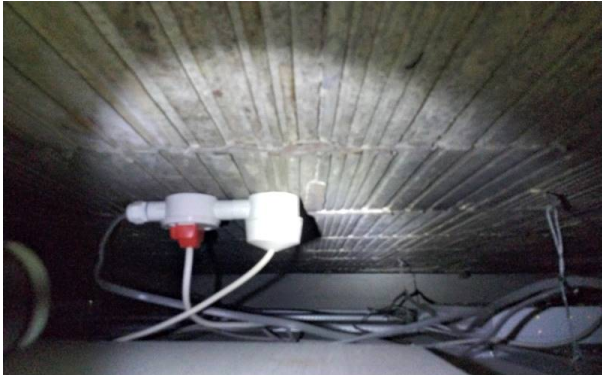
<b>Item / Inspection Ref:</b>	#50	Material Assessment	Product type:

<b>Sample Ref:</b>			Condition / Damage:		
Survey date:	15/08/22 TO 16/08/22		Surface Treatment:		
Analysis date:			Asbestos Type:		
Building:	Tenants Hall		<b>Material Score:</b>		
Floor level:	Ground Floor		Occupant Activity:		
Room:	Office 4		Location:		
Position:	Ceiling		Accessibility:		
Item Description:	Visual Inspection		Extent/amount:		
Level of Identification:	N/A		Number of Occupants:		
<b>Action:</b>		Frequency of Use:			
<b>RISK CODE:</b>	<b>No Asbestos</b>	Priority Assessment	Time in Area:		
			Maintenance activity:		
			Frequency of Maintenance:		
			<b>Priority Score:</b>		
<b>Total Score:</b>					
<b>Comments:</b>	Ceiling Void

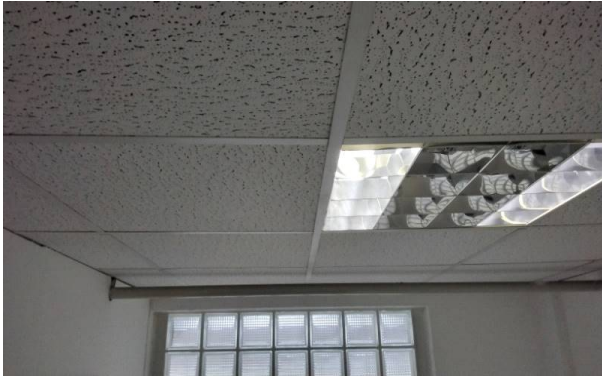
<b>Item / Inspection Ref:</b>	#51	<b>Material Assessment</b>	Product type:

<b>Sample Ref:</b>	As Sample SY004167		Condition / Damage:			
Survey date:	15/08/22 TO 16/08/22		Surface Treatment:			
Analysis date:			Asbestos Type:			
Building:	Tenants Hall		<b>Material Score:</b>			
Floor level:	Ground Floor		<b>Priority Assessment</b>	Occupant Activity:		
Room:	Office 4			Location:		
Position:	Ceiling			Accessibility:		
Item Description:	Unknown - Ceilings			Extent/amount:		
Level of Identification:	STRONGLY PRESUMED			Number of Occupants:		
<b>Action:</b>	None required	Frequency of Use:				
<b>RISK CODE:</b>	<b>No Asbestos</b>	Time in Area:				
		Maintenance activity:				
		Frequency of Maintenance:				
		<b>Priority Score:</b>				
<b>Total Score:</b>						
<b>Comments:</b>	Grid tiles

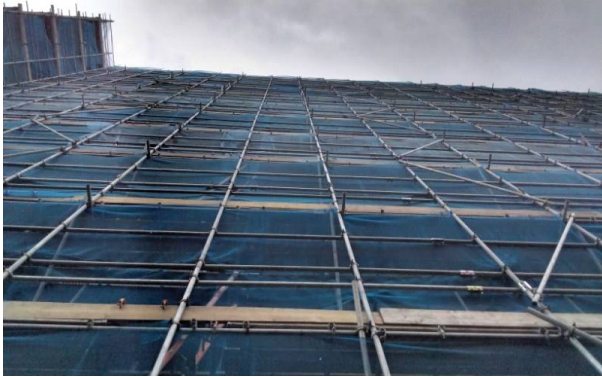
<b>Item / Inspection Ref:</b>	#54	Material Assessment	Product type:

<b>Sample Ref:</b>			Condition / Damage:		
Survey date:	15/08/22 TO 16/08/22		Surface Treatment:		
Analysis date:			Asbestos Type:		
Building:	Tenants Hall		<b>Material Score:</b>		
Floor level:	External	Priority Assessment	Occupant Activity:		
Room:	External		Location:		
Position:	Roof		Accessibility:		
Item Description:	No Access		Extent/amount:		
Level of Identification:	INACCESSIBLE (PRESUMED)		Number of Occupants:		
<b>Action:</b>			Frequency of Use:		
<b>RISK CODE:</b>	<b>No Access</b>		Time in Area:		
		Maintenance activity:			
		Frequency of Maintenance:			
		<b>Priority Score:</b>			
		<b>Total Score:</b>			
<b>Comments:</b>

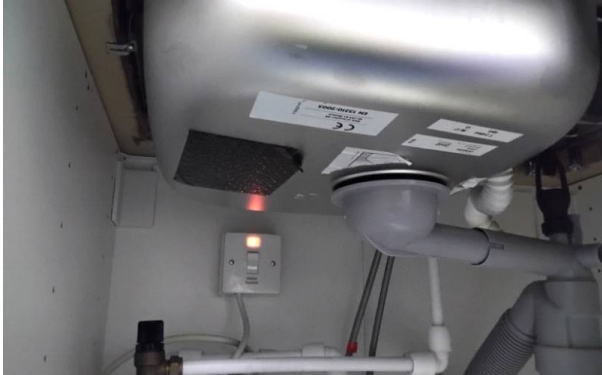
<b>Item / Inspection Ref:</b>	#55	Material Assessment	Product type:

<b>Sample Ref:</b>	SY004179		Condition / Damage:			
Survey date:	15/08/22 TO 16/08/22		Surface Treatment:			
Analysis date:	August 18 2022		Asbestos Type:			
Building:	Tenants Hall		<b>Material Score:</b>			
Floor level:	Ground Floor		Priority Assessment	Occupant Activity:		
Room:	Office 3			Location:		
Position:	Sink			Accessibility:		
Item Description:	Sink pad			Extent/amount:		
Level of Identification:	SAMPLED			Number of Occupants:		
<b>Action:</b>	None required	Frequency of Use:				
<b>RISK CODE:</b>	<b>No Asbestos</b>	Time in Area:				
		Maintenance activity:				
		Frequency of Maintenance:				
		<b>Priority Score:</b>				
		<b>Total Score:</b>				
<b>Comments:</b>
